Report on Investigations at Aldenham Research Site

January 2010

Findings are published every month in the CRG newsletters. This special edition reviews the results of site investigations, soil testing and precise levels in the vicinity of the Headmaster’s House following notification of damage in the summer of 2009.

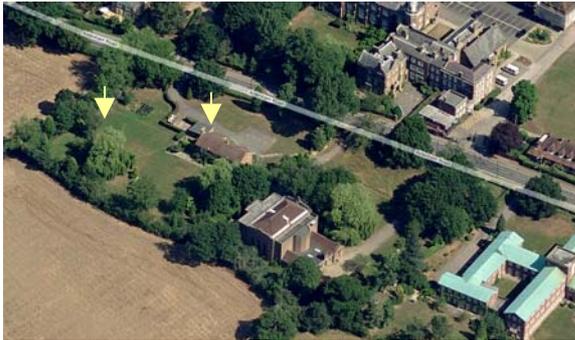
The site has been described in detail previously. Arrows on the image below indicate the relationship between the Willow and house.

To the left, arrowed, is the “Aldenham Willow”, the subject of our study over the last 3 years. The right arrow indicates the Headmasters House .

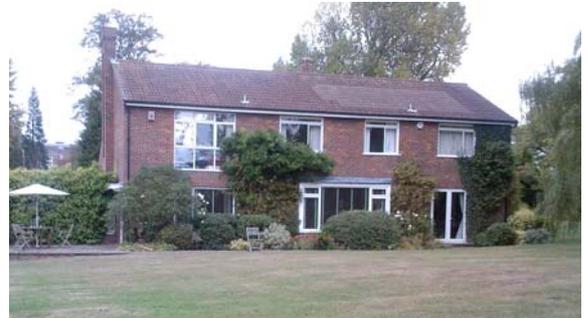
Below is a picture of the rear elevation of the damaged building showing the numerous shrubs (Wisteria?) growing against the house wall.

Rear elevation of the Headmasters House. A mature Wisteria is growing to the left of the bay window.

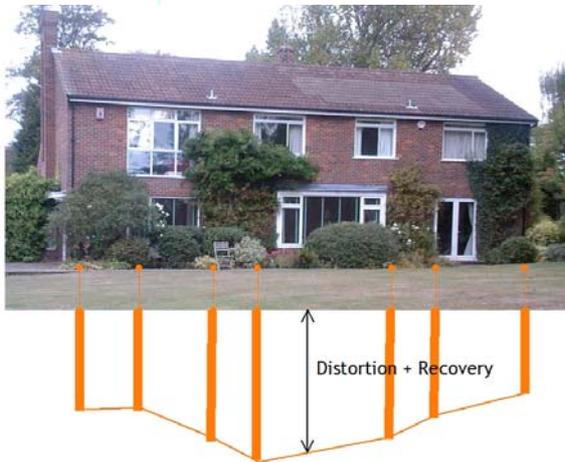
There two sets of readings. The first is a distortion survey, taken on the same bed joint and measuring ‘warts and all’ variations. That is, variations that may be due to initial building setting out problems or subsequent ground movement.

Both flank walls show downward slopes towards the rear corners of the house of 40 – 46mm possibly implicating the surrounding trees. The maximum distortion has the Wisteria as a focal point, one-third the way along the rear house wall.

It would appear that the trees have exerted an influence, but the cause of recent damage is more likely to be the shrubs along the rear house wall, and the large Wisteria in particular.

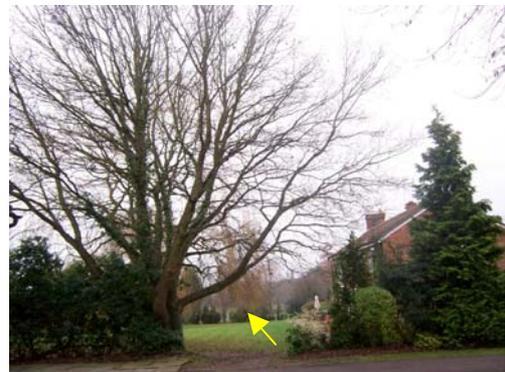
Trees situated to the rear left hand corner of the building in the foreground, and the 'Aldenham Willow' just visible in the distance, arrowed.
