The Clay Research Group

Monthly Bulletin

Modelling – taking account of the site

October 2006.

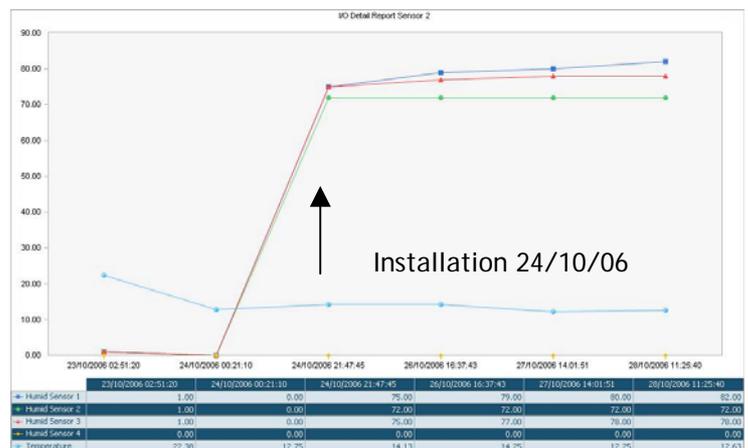
The installation comprises 3 moisture and 1 temperature sensor. The latter is incorporated within the datalogger, and records the ground temperature. The final location was determined by the need to avoid the football pitches.

Bentonite was used to seal around the probes. They were installed at an angle of around 20 degrees. Cable lengths restricted the distances from the datalogger to the various sensors to around 6mtrs, not 8mtrs as shown.

TDR1 - Code ML2 183/029 - 700mm bGL
TDR2 - Code ML2 183/028 - 1.1m bGL
TDR3 - Code ML2 183/024 - 700mm bGL - control

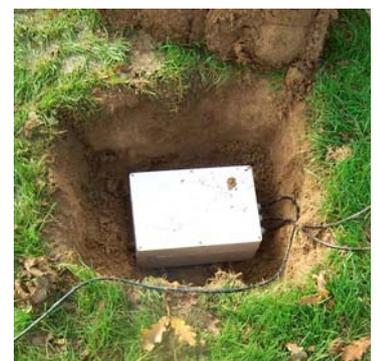
Below we see the logger about to be buried and above is the graphical output from the web. We are using this technology to record movement (both building and moisture change) over time.

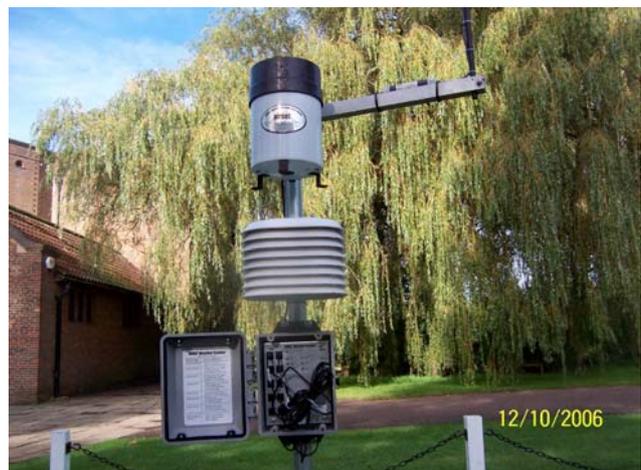
Turning it on would be helpful! After a few months of head scratching and checking the web for data, we thought it might be useful to press the little button that said 'ON'.

In fact, it didn't make any difference. We have a small problem with the datalogger and the manufacturers - Temcon - have been very helpful indeed. They have taken it away to see what can be done to repair it.

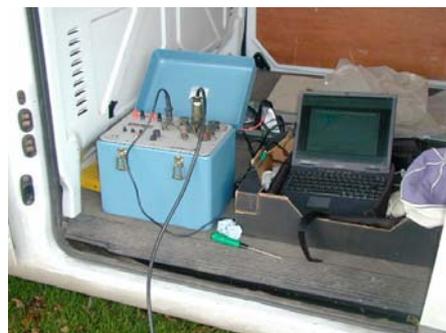
Left we see the ER kit, with readings being taken from a laptop computer between probes cycling through various permutations of spacing to provide values at depth. Thanks to Gary Strong for the snap.

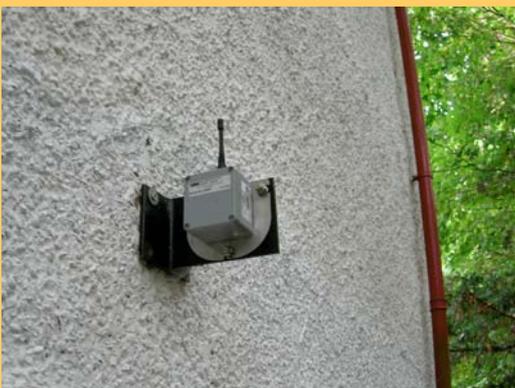
Electrolevel Installation

It is important to ensure the sensors are installed in a location, and at an orientation, to capture any movement that takes place.

At the test site the sensor was secured to an angle bracket to ensure we were measuring movement in the plane of rotation.

This sensor is recording the movement we see plotted on Page 4. Had it simply been fixed to the wall without the bracket, it is unlikely we would have recorded any movement at all.

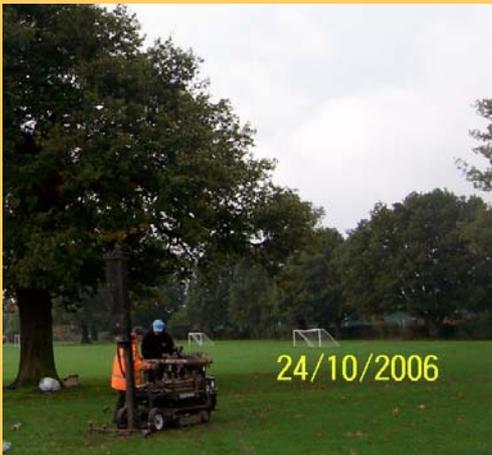
Part of the project is to see what effect sample disturbance has on oedometer testing. Traditional engineering truth finds the idea simply absurd.

MatLab have been using the test on disturbed samples and comparing the outcome with the filter paper method for many years, and found a good correlation.

The trick appears to be sample preparation and the method of consolidation and this stage of the research is aimed at resolving this issue if possible.
