# The Clay Research Group

Edition 142

Issue 142, March, 2017

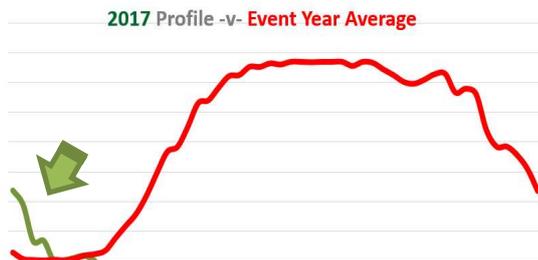
Soil Moisture Deficit plot showing soil drying (green) compared with average for event years (red). Data supplied by the Met Office for Tile 161, Medium AWC, grass cover.

Soil is at equilibrium capacity for the start of 2017, and far too early to predict summer claim numbers.

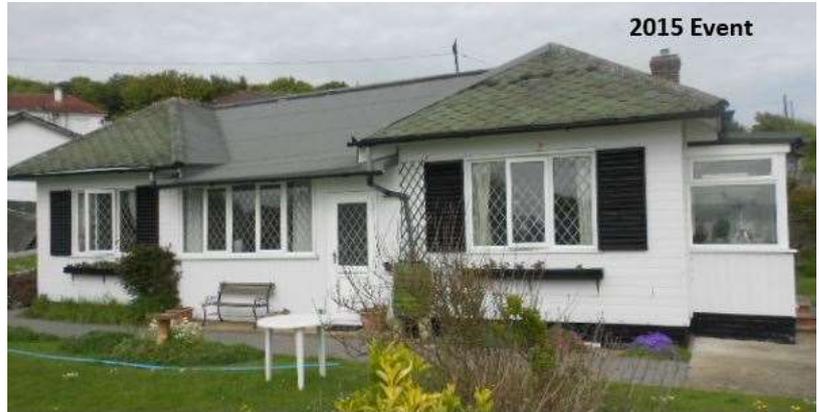
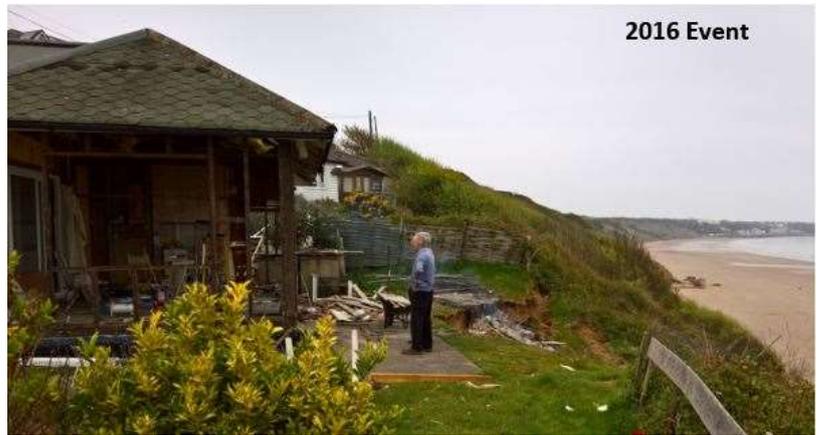
## Landslip at Filey, Yorkshire

Right, the before and after pictures tell the story.

Movement had been ongoing for some time as the cliff face eroded.

Further minor damage was reported in 2015, and catastrophe struck in 2016 when part of the bungalow was lost to the eroding cliff face.

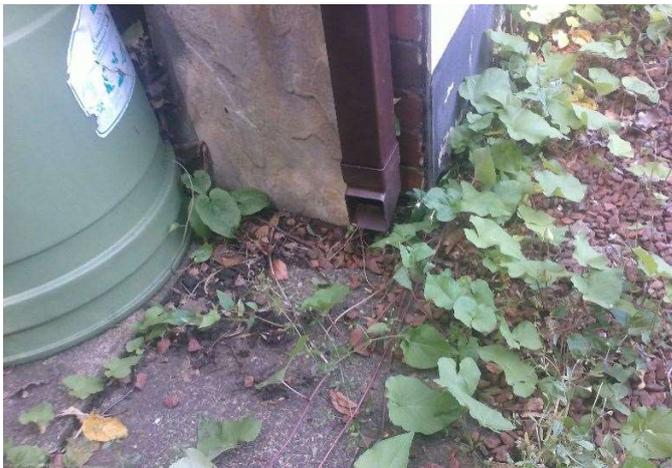
Rainwater downpipe discharging directly into the ground. A non-cohesive soil supporting the foundations.

What could possibly go wrong? Yes, water discharging from the downpipe softened and eroded the underlying soil, resulting in minor damage to the corner of the house.

Frustratingly, a water storage butt is nearby.

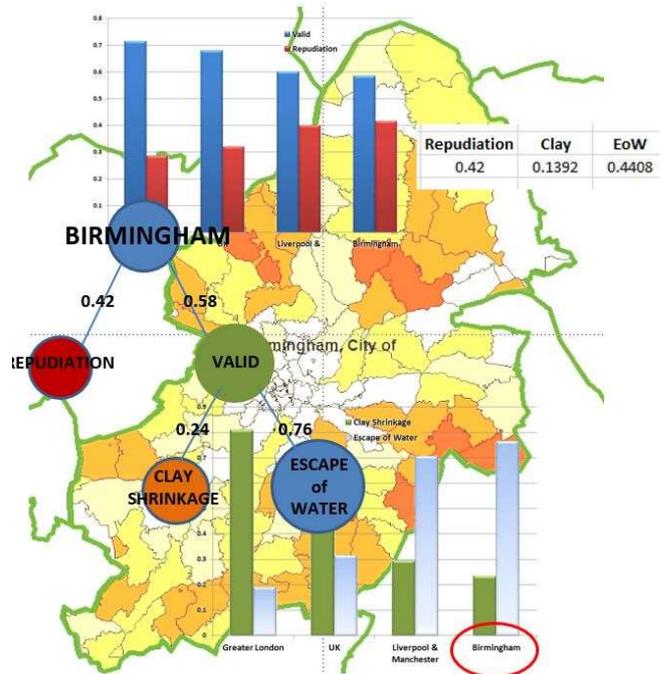
For **Birmingham** (right), the chances of a claim being valid are slightly less, at 58%.

The dominant peril is an escape of water from the drainage system or less likely, a water service pipe. Clay shrinkage accounts for 24% of valid claims, and leaking drains etc., the balance of 76%.

Of all claims (declined and valid), 14% are related to clay shrinkage (predominantly associated with the smectite rich clays to the south east of the city) and 44% escape of water.

Birmingham, mapping claim frequency distribution and likely operating peril.

The table (top right of the image in all instances) resolves the distribution as percentages of the whole sample.
