The Clay Research Group

Edition 174

Issue 174, November 2019

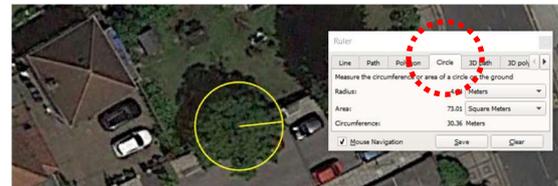
Middle, measuring the canopy radius, area and circumference of the nearby tree.

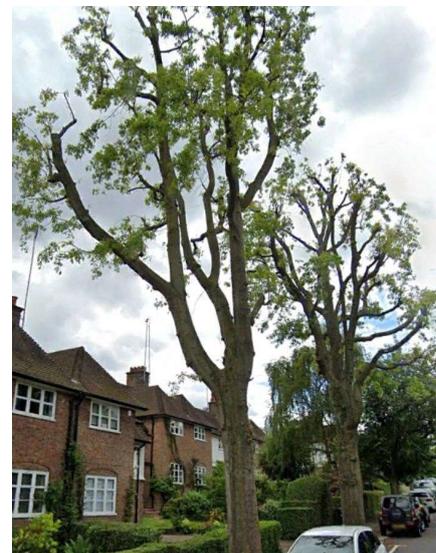
Right, a 3D view of a property obtained by zooming in on the screen image on Google Earth. Here we have selected a view based on its clarity - the imagery is not always as clear as the example shown.

Using the mouse, click on the top and (estimated) base of the tree. The information screen indicates it as being 12.34m tall. The house is estimated to measure 5.3m to the eaves.

The building footprint is recorded as being 48m² using LiDAR and 47m² measuring the Google Earth image. The distance between the tree and house is 13mtrs in both, which agrees with the engineer’s site measurement. The tree was 19m tall in the LiDAR scan (2006) and 17m tall measured from the Google image (2019). As can be seen from the picture right, the tree canopy has been reduced in height and thinned, possibly explaining the differences between the measurements.

No doubt an arboricultural expert could identify the tree species from the Street View photograph. In this case we used the i-Tree web site recording London street trees which identifies the tree as an oak. In summary, the method provides a useful overview, available from a desk-top study. There is no claim to accuracy given the size and resolution of the imagery, but relative proportions are useful when (as is the case here) it is likely given the metrics and species that the root zone extends beneath the property.

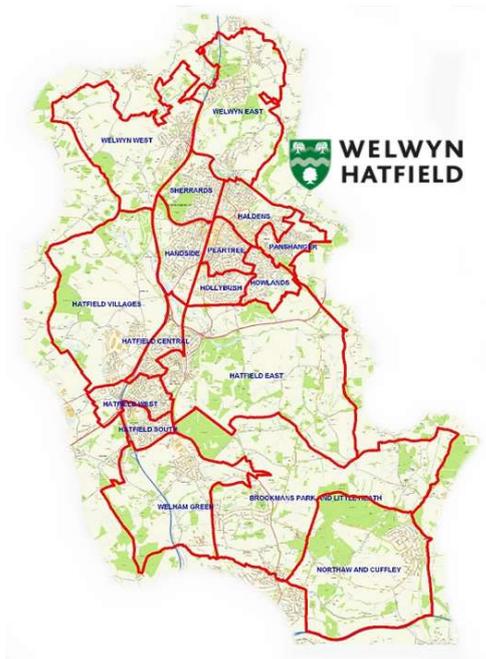
Layout of the Welwyn Hatfield borough in Hertfordshire. The borough has an estimated population of around 123,000 and an area of 129.6km².

Welwyn Hatfield is rated 1.83 times the risk of the UK district average in terms of subsidence. The highest risk rating on this scale is a value of 4.
